Technical Report Series

Three Firefighters Die in Pittsburgh House Fire Pittsburgh, Pennsylvania

Investigated by: J. Gordon Routley

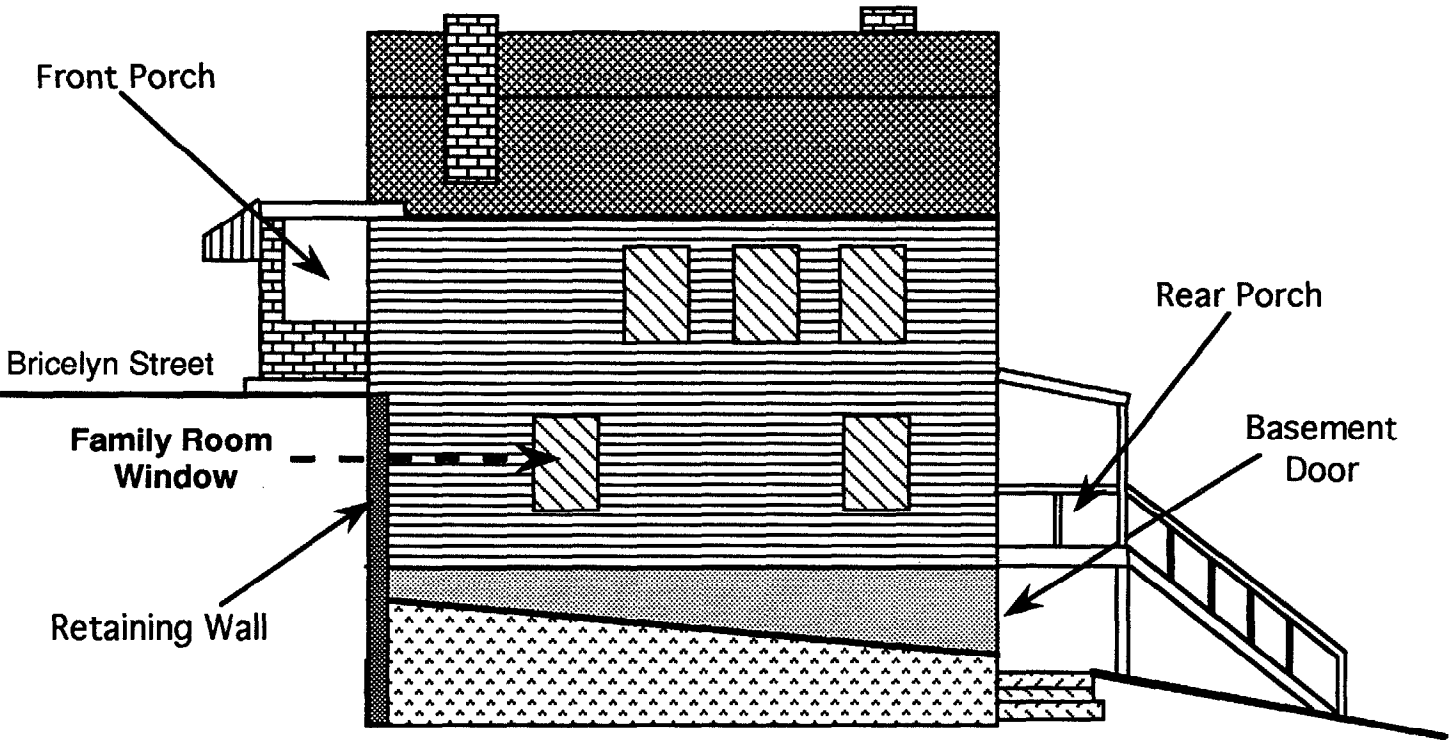
EAST SIDE OF DWELLING - 8361 Bricelyn Street

The kitchen and family room were located on the first floor, the living room and one bedroom were on the second floor, and two additional bedrooms were on the third floor. The heating equipment, a washer and

drier, and storage areas were located in the basement. The furnace, water heater and clothes drier were all fueled by natural gas.

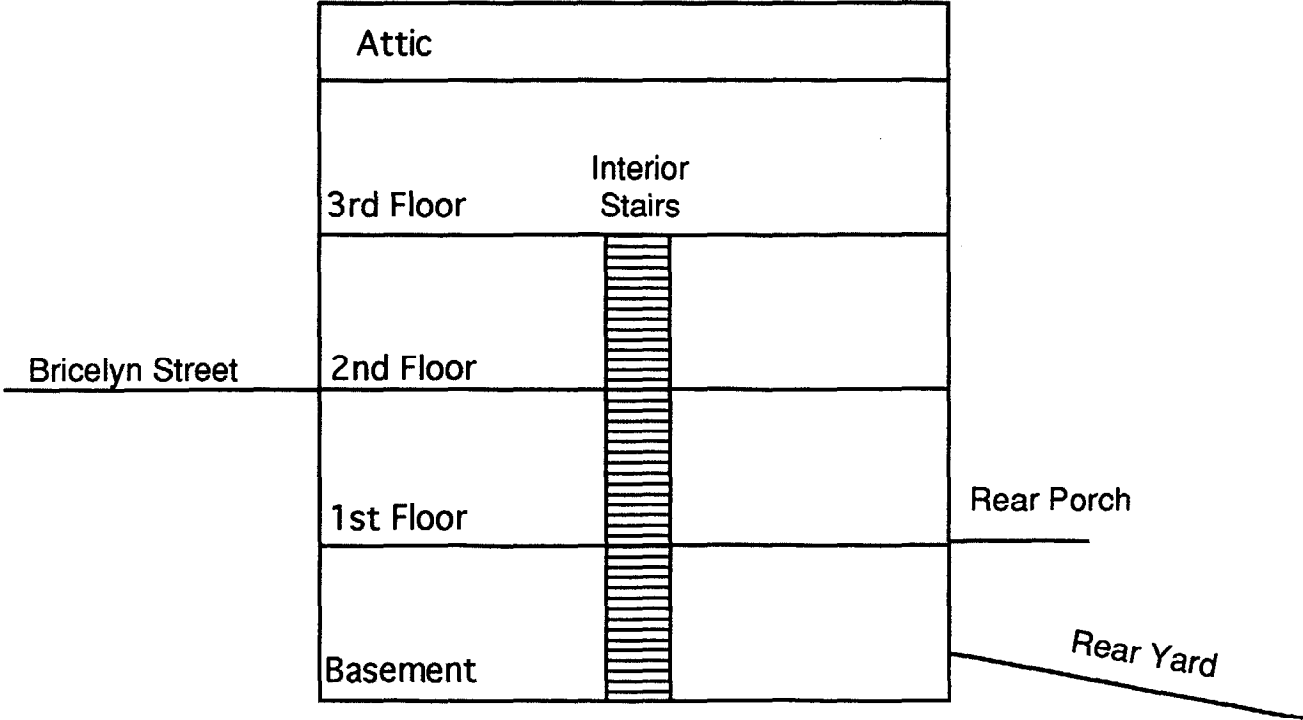
INTERIOR CROSS SECTION

The three stair sections were stacked, one directly above another, and divided each floor into front and rear sections. A wood door at the top of the basement stairs opened into a narrow vestibule on the first floor; when this door was open it blocked the opening between the kitchen at the rear and the family room at the front. There were no doors in the stairways between the first and second or the second and third floors.

The fire was determined to have been caused by arson and originated in the basement, directly under the kitchen. This would place the point of origin close to the gas-fired appliances. The fire first involved contents in the basement, then extended upward through void spaces in the exterior walls and around the stairway. The void spaces allowed the fire to extend directly to the attic. It later broke through the walls and/or ceiling and involved the bedrooms on the third floor.

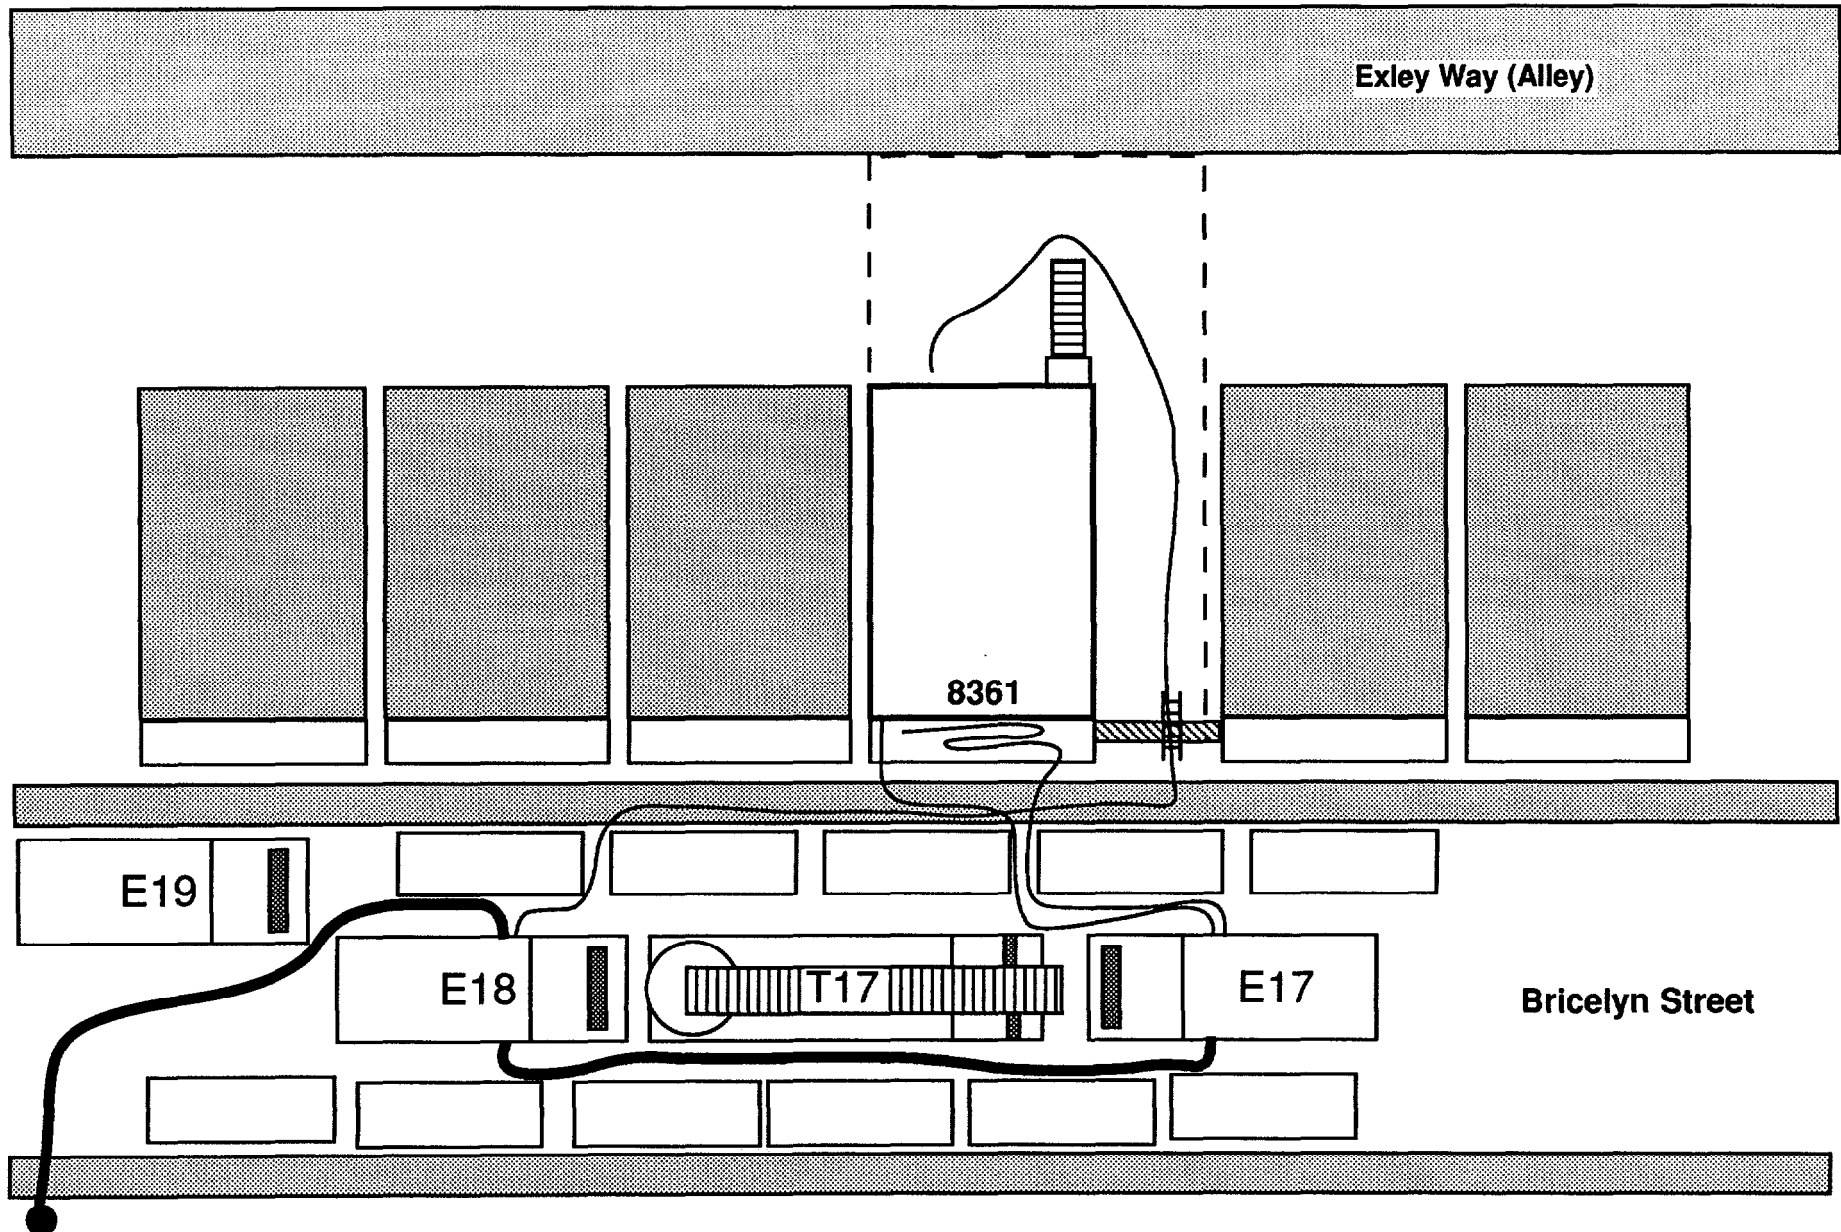
LOCATIONS OF FIRST ALARM COMPANIES

The initial response consisted of Engines 17, 18, and 19, Truck 17, and Battalion Chief 2 (Unit 4042). Engine 19 was dispatched in place of Engine 15, which was on another call, and Battalion Chief 2 was responding in place of Battalion Chief 3. Battalion Chief 3 (Unit 4043) became available after the call was dispatched and replaced Battalion Chief 2 on the assignment. The Emergency Medical Services Division dispatched Medic 11 and Rescue 1 on the first alarm, each with two paramedics on board. (Pittsburgh EMS is a separate division of the Department of Public Safety.)

Engine 18 had arrived at 0032 hours. The crew stretched a 5 inch supply line from a hydrant and connected it into their pump, and then stretched another 5 inch line from Engine 18 to Engine 17. After positioning the ground ladder, they advanced a 1-3/4 inch attack line from their apparatus down the ladder to the side yard and around to the rear of the involved house. They observed the fire in the basement and operated the hose line through the rear basement window. The captain went to the roof to assist Truck 17, leaving the two firefighters to operate the line.

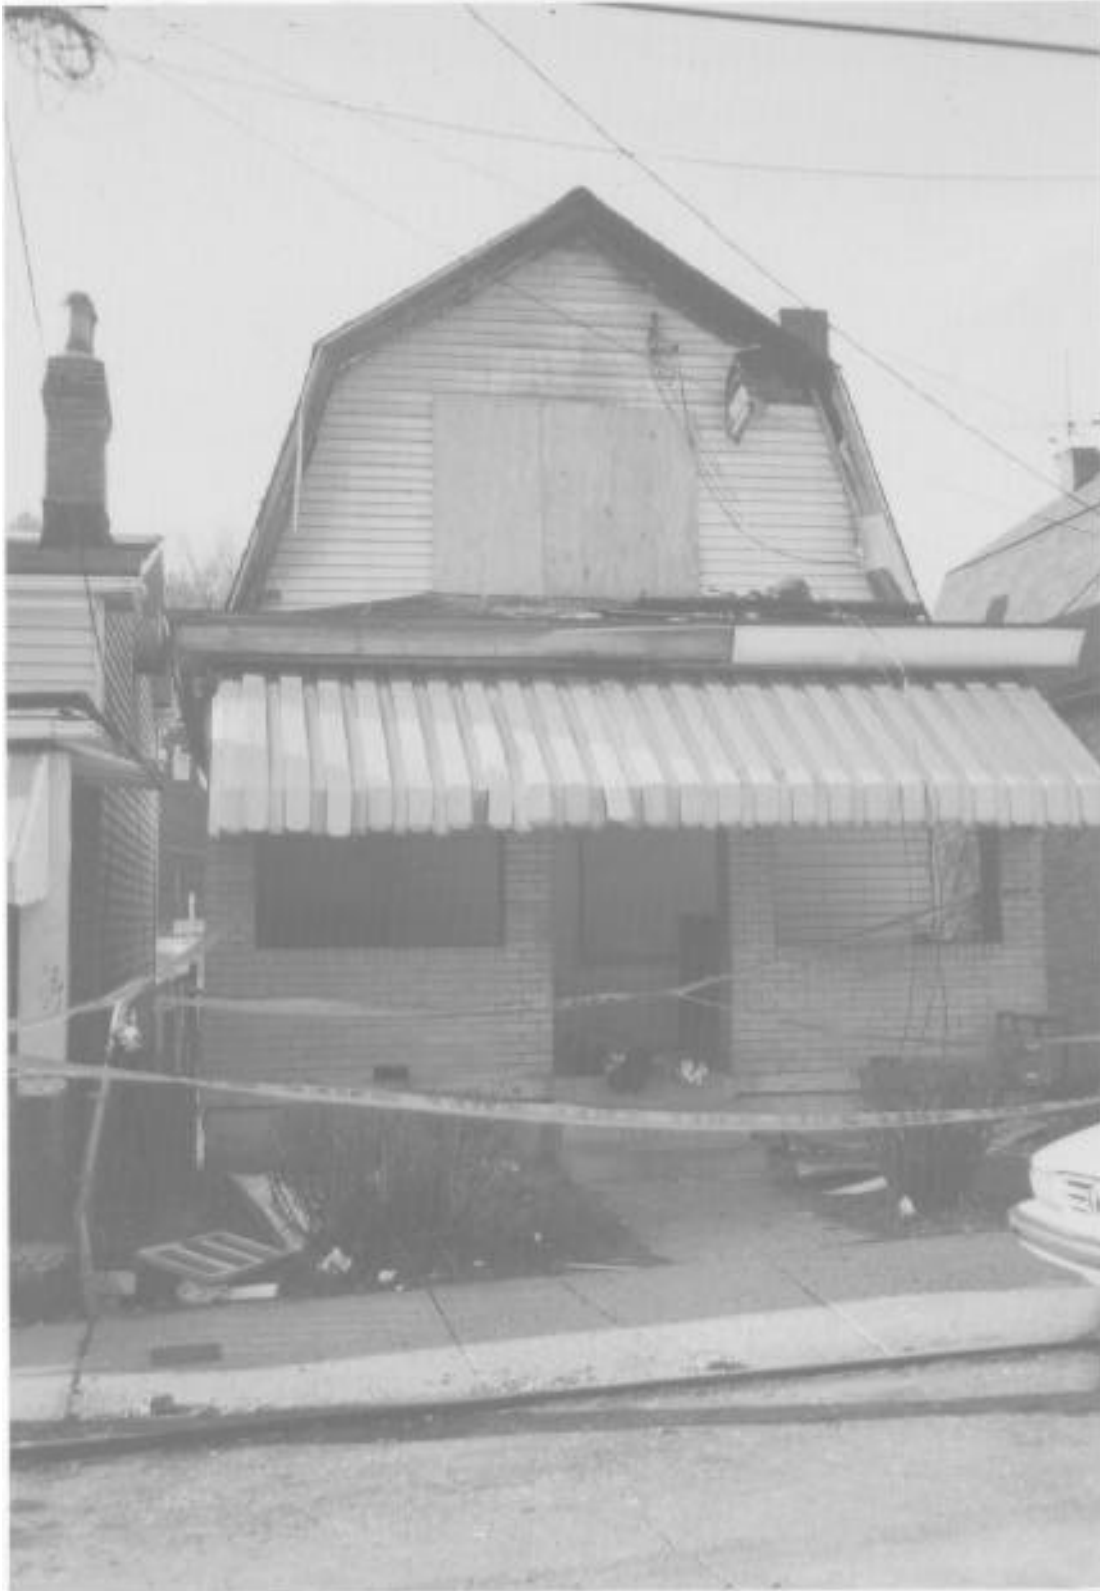
Front view of 8361 Bricelyn Street.

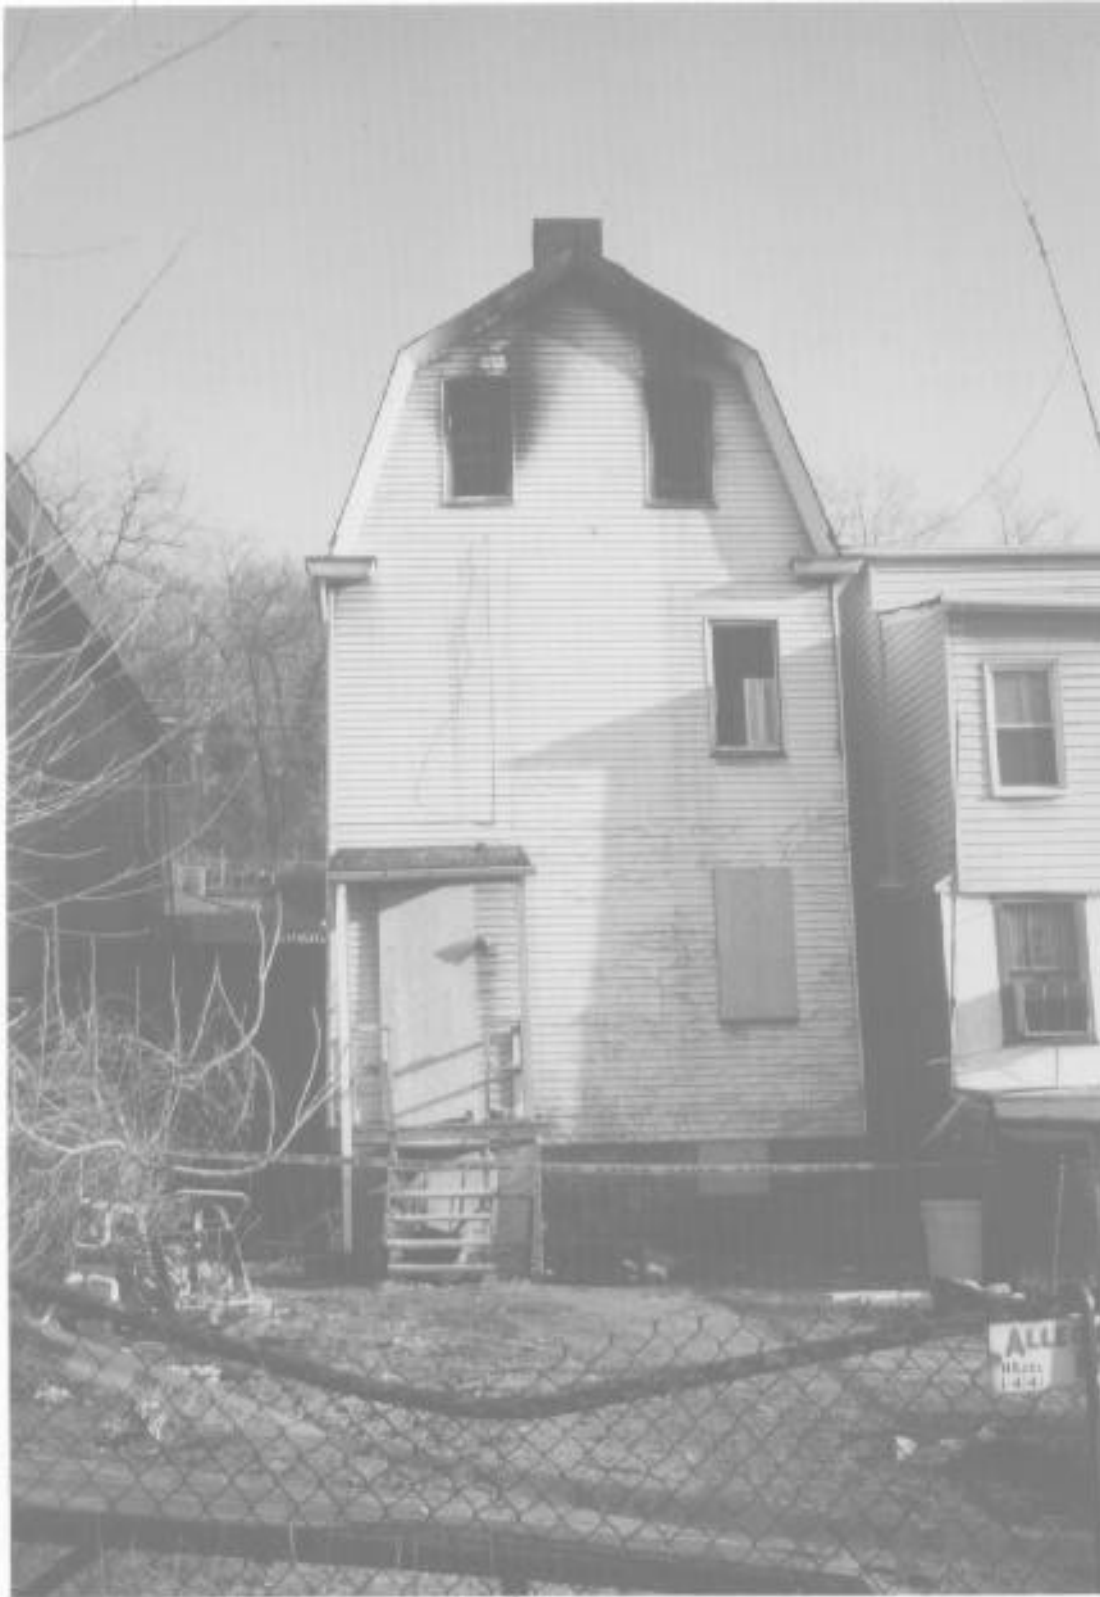
Rear view of 8361 Bricelyn Street.
